KENTUCKY HISTORIC RESOURCES
INDIVIDUAL SURVEY FORM
(KHC 2002-1)

COUNTY Lewis
RESOURCE # Lw-65
RELATED GROUP #
EVALUATION S
SHPO EVALUATION 5
DESTROYED

1. NAME OF RESOURCE (how determined): 9/ House

HC 74 Box 420 State Route 8; SE corner SR 8 and Sand Branch Road
Buena Vista, KY. 41179

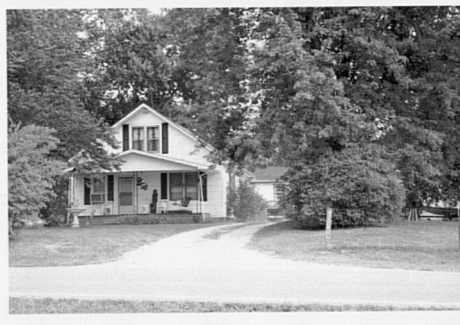
Located on the south side of State Route 8, this property is a slightly asymmetrical 1.5 story, three-bay frame house with a full-width front porch supported by replacement metal posts, and resting on a rusticated block foundation. The property has both single and paired 1/1 double-hung wood sash windows, which appear to be original, and are covered by storms. The half-lite wooden front door also appears to be original and is covered by a storm door. The property has been entirely clad in beveled lap vinyl siding.

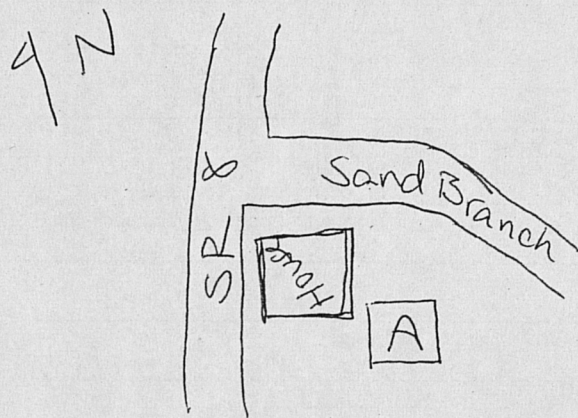
26. SITE PLAN (Complete if #25 was answered).

A frame two-car garage/ carriage house is located behind the house, and just slightly to the west. On the upper level, the carriage house has 6/6 double-hung sash windows.

25. SUPPORT RESOURCES: SITE PLAN KEY
A

FUNCTION
Two-car Garage
